CALSPAN LIMITED ON-SITE AIR BAG DEPLOYMENT INVESTIGATION

CASE NO. 90-19

FLEET - 1990 FORD TAURUS GL STATION WAGON

CALSPAN CASE NO. 90-19

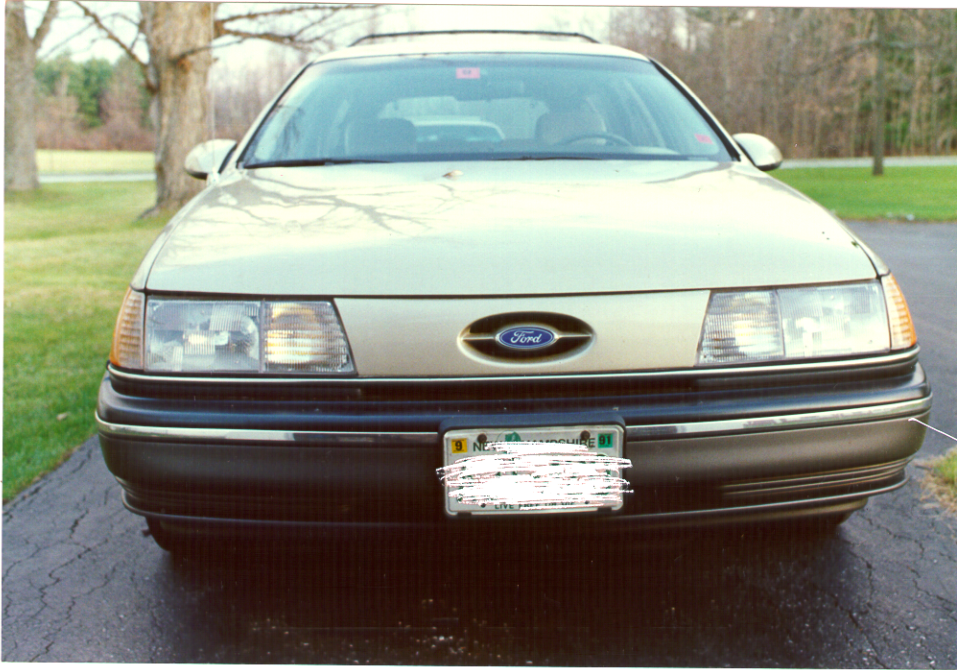
Frontal View Of The Repaired Ford Taurus

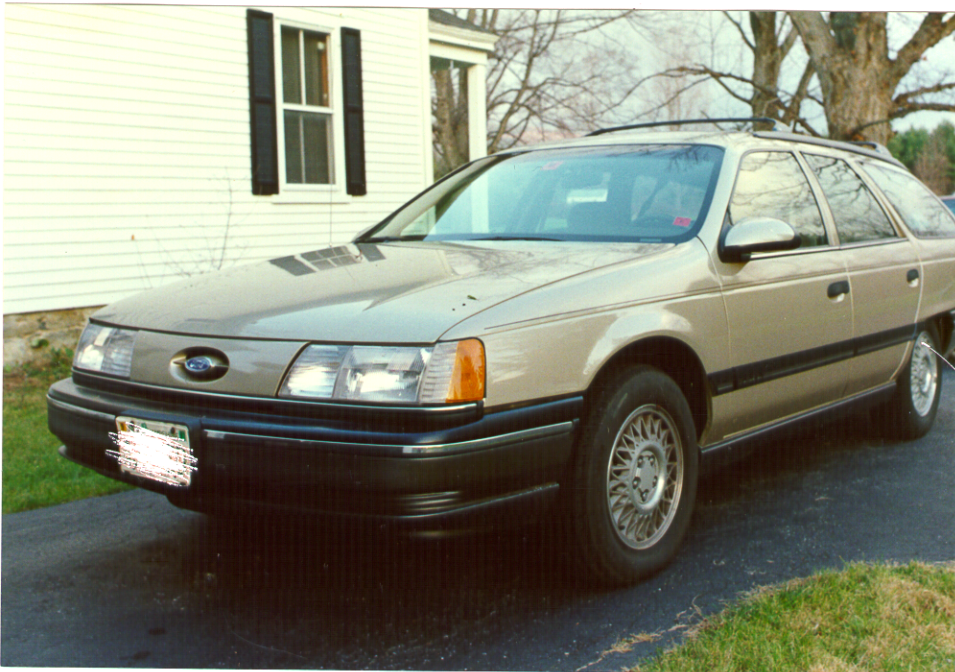
Left Front Three-Quarter View Of The Vehicle

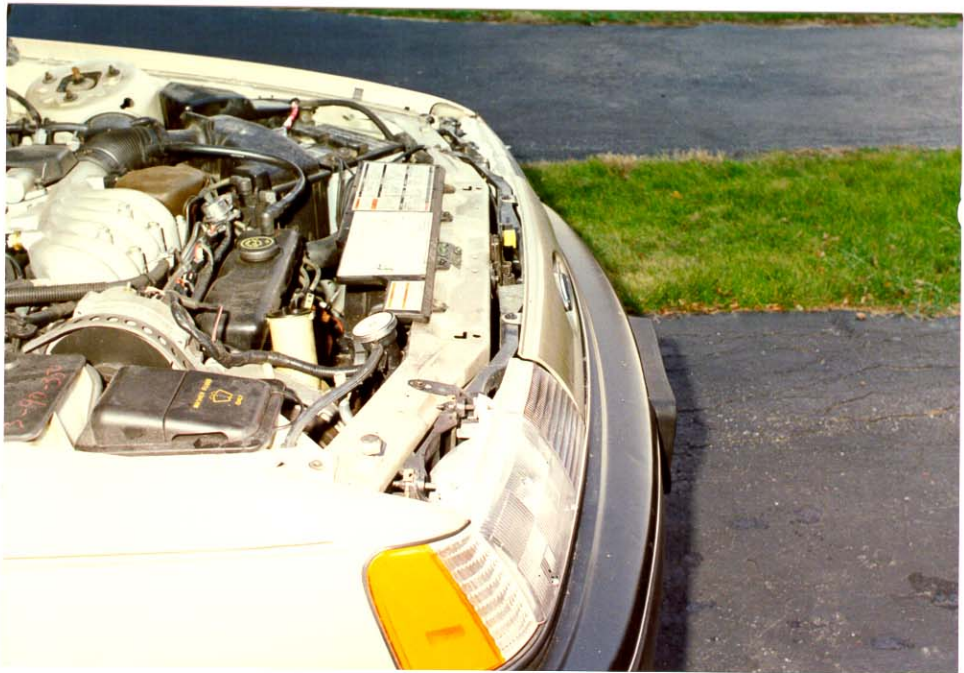
Perpendicular View Across The Radiator Support Panel

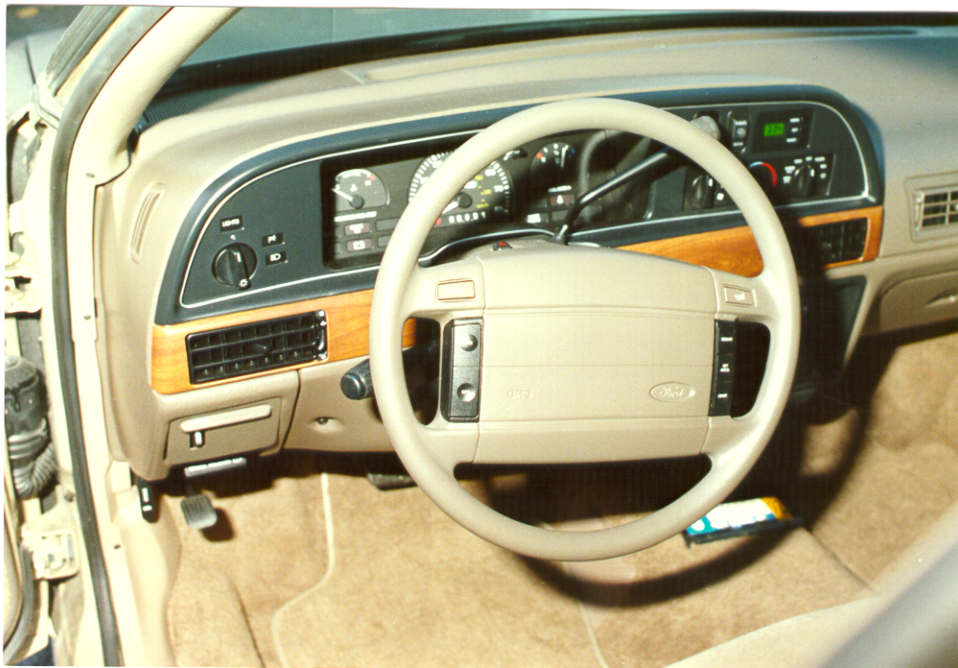
Replaced Driver Air Bag Module

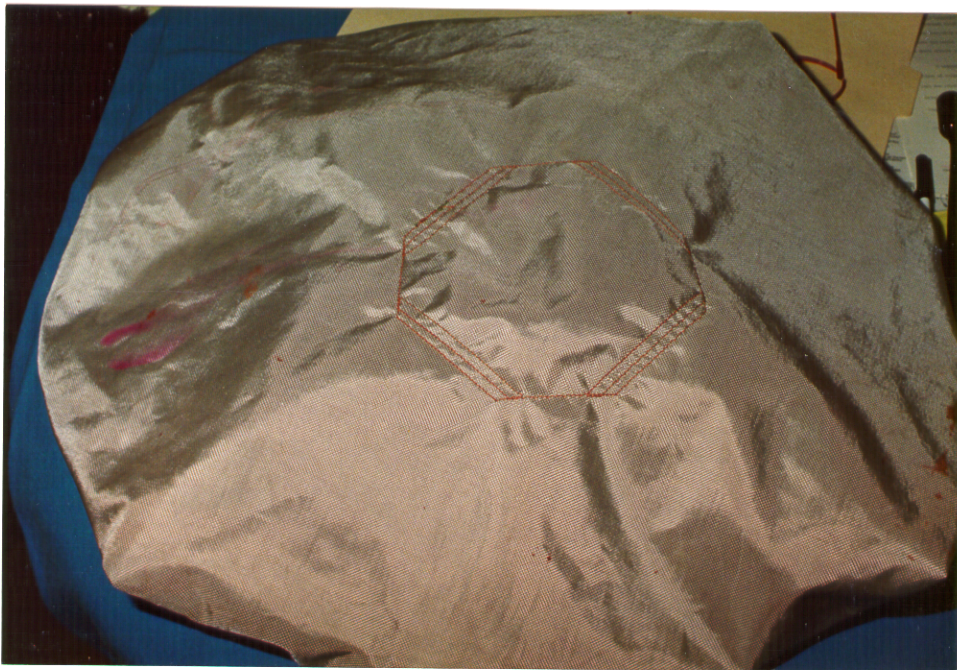
Deployed Driver Air Bag

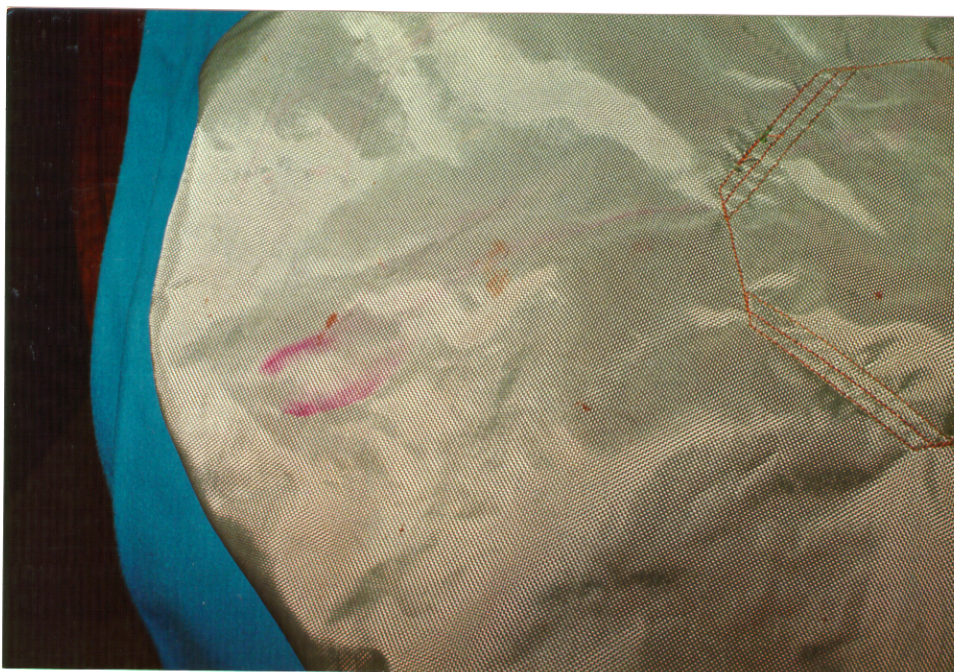
The driver's initial contact with the deployed air bag was located at the 8:45 - 10 o'clock position of the bag. A lipstick transfer was located 9 - 11.25" left of center and .25 - 1.75" below the horizontal centerline of the air bag. A faint continuation of the lipstick transfer extended to the center (tether reinforcement) area of the bag. An oblong makeup deposit was located 6.5 - 12.25" left of center which extended .25 - 3.0" above the horizontal centerline. There was also a faint crossing pattern that appeared to be a lipstick transfer that was centered 8.25" left and 4.75" above the horizontal centerline. This transfer probably occurred post-crash as the bag deflated. Blood spatters were noted to both sides of the air bag as the driver remained in her vehicle following impact.

Lip Stick Transfer On The Air Bag At The 8:30 Position

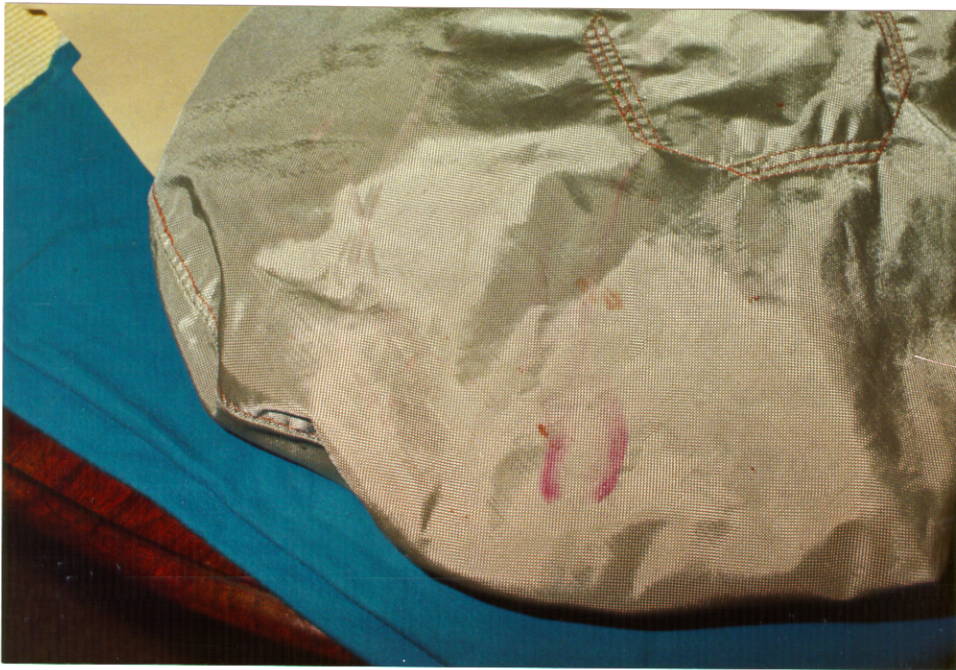
Lip Stick Transfers Fade At The Tether Reinforcement Stitching

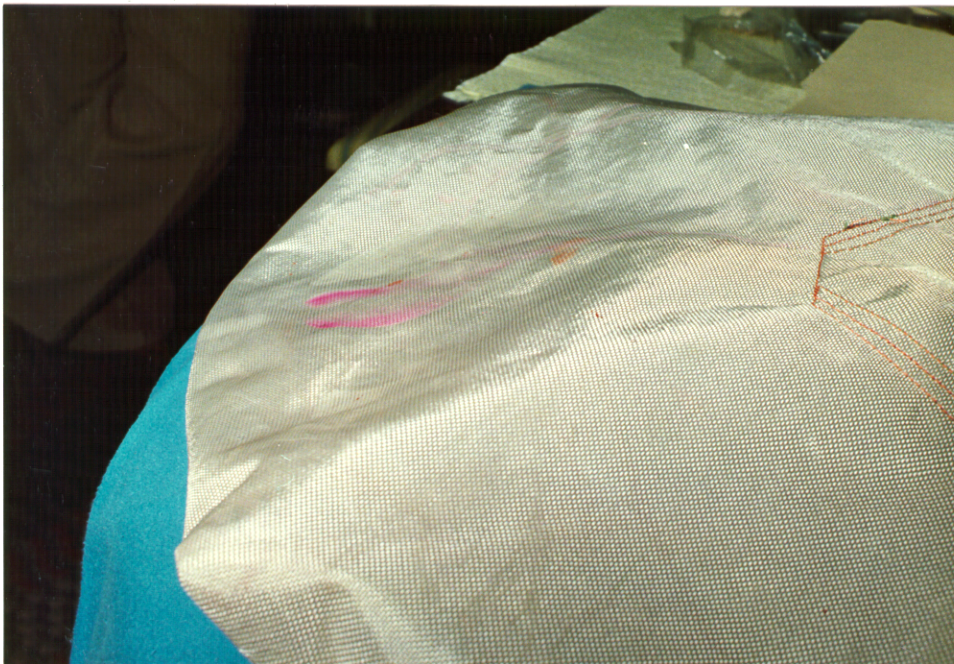
Makeup Transfers Above The Lip Stick

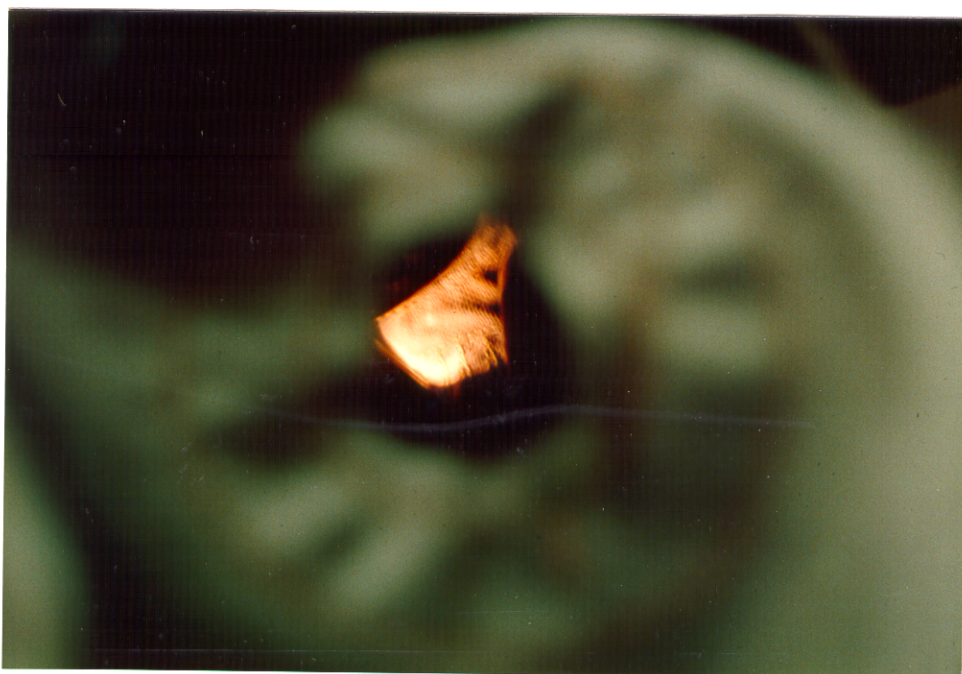
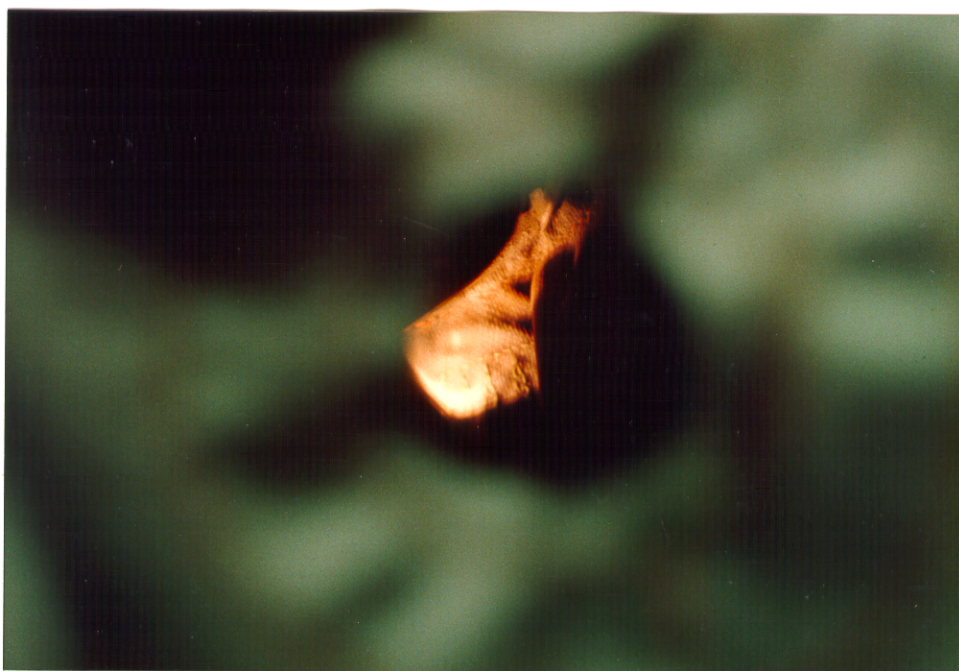
Calspan conducted an on-site inspection of the module assembly on ~~XXXXXX~~, and verified the location of the facial transfers and internal generant residue deposit. The internal generant residue deposit was located at the 6:30 - 7:30 o'clock position on the neoprene lining adjacent to the steel inflator unit. The residue also covered 3 orange stitches that the husband initially reported as burned away. There was also a small deposit of residue on the filtering screen at the 4 o'clock position. No screen material at the inflator ports was burned or deformed.

A Calspan representative inspected the air bag module assembly with the driver's husband at their residence on [REDACTED] 1990. Using a similar inspection method with a flashlight and viewing through the right venting port, the residue deposit was visible on the inside surface of the air bag immediately outboard of the inflator. The deposit was, however, located at the 6:30 - 7:30 o'clock position on the bag material and at 5:30 - 7:30 on the steel inflator housing. The residue also covered the three orange stitches previously mentioned. The stitches were in place and were not burned through or missing. The remainder of the interior surface of the air bag was clean, with no deposits or discoloration.

The filter screen of the inflator port at the 4 o'clock position contained a deposit of generant residue; however, the filter was intact with no visible (exterior) burn-through. The internal deposits were located approximately 45 - 75° counterclockwise or below the husband's original reported positions.

Generant Residue Deposits On The Inside Surface Of The Air Bag
Adjacent To The Inflator Assembly At The 6:30 - 7:30 O'Clock Position

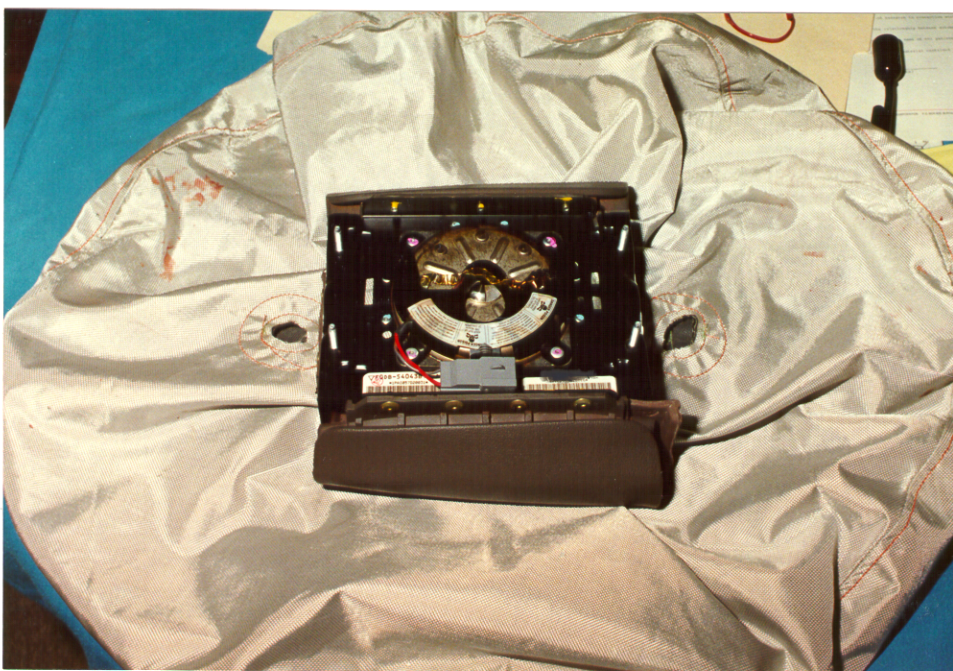
Posterior View Of The Air Bag And Inflator Assembly

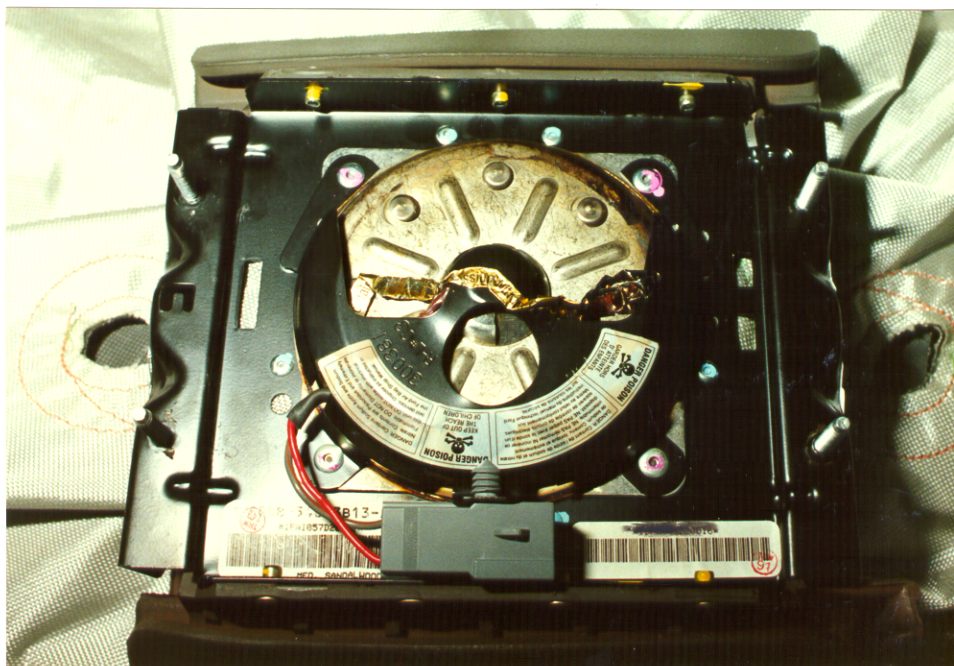
Close Up View Of The Inflator

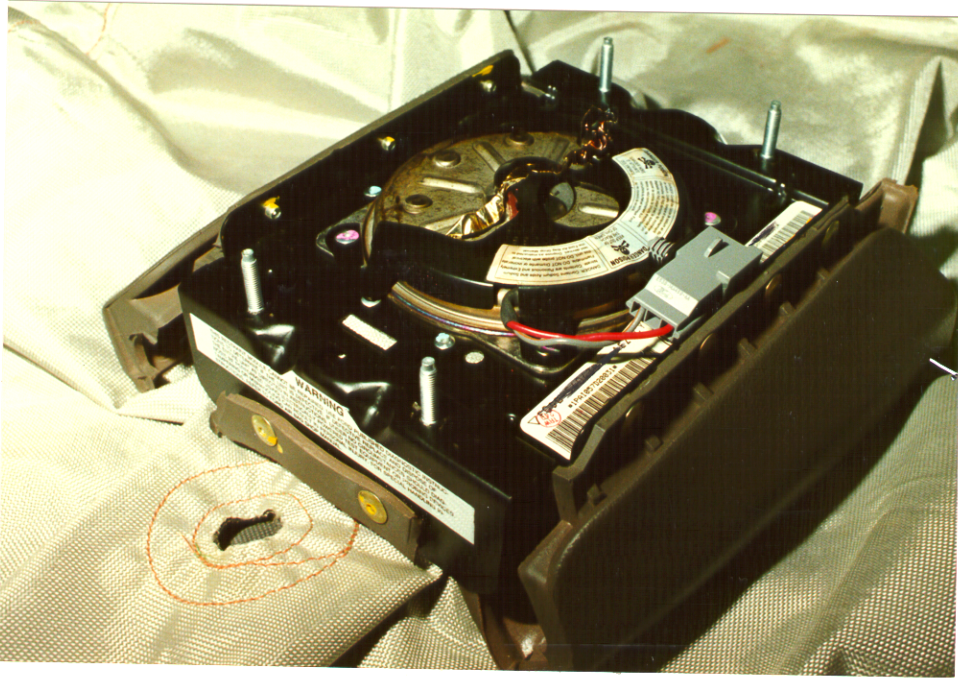
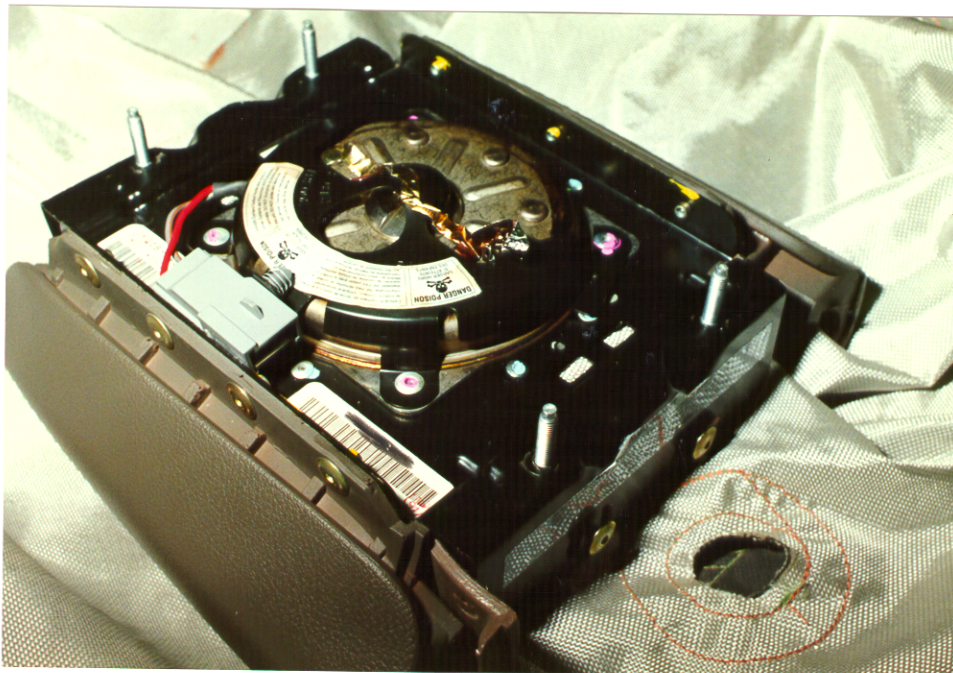
Offset Views Of The Inflator Assembly

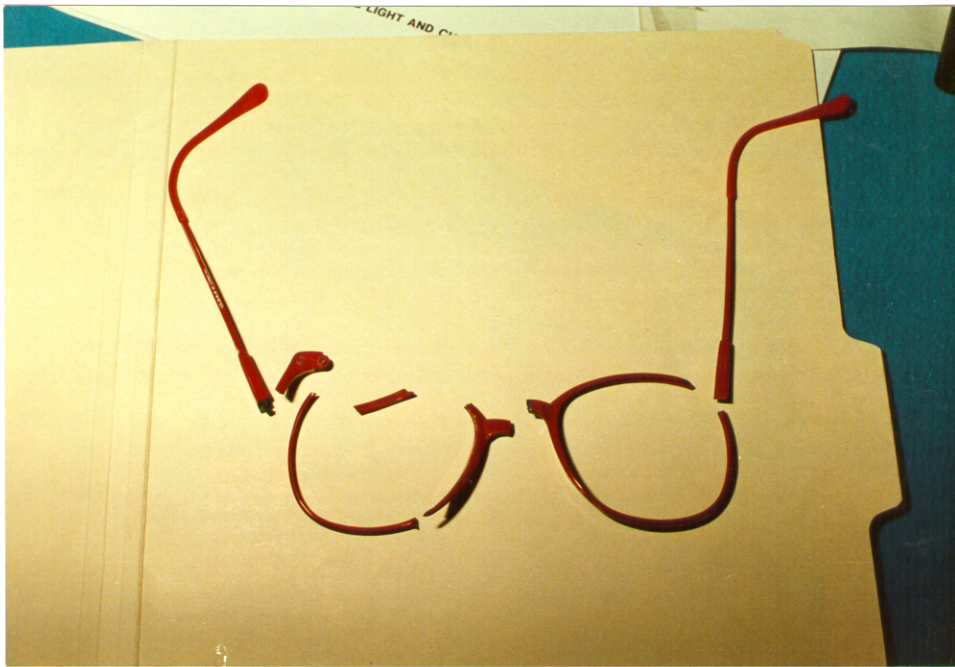
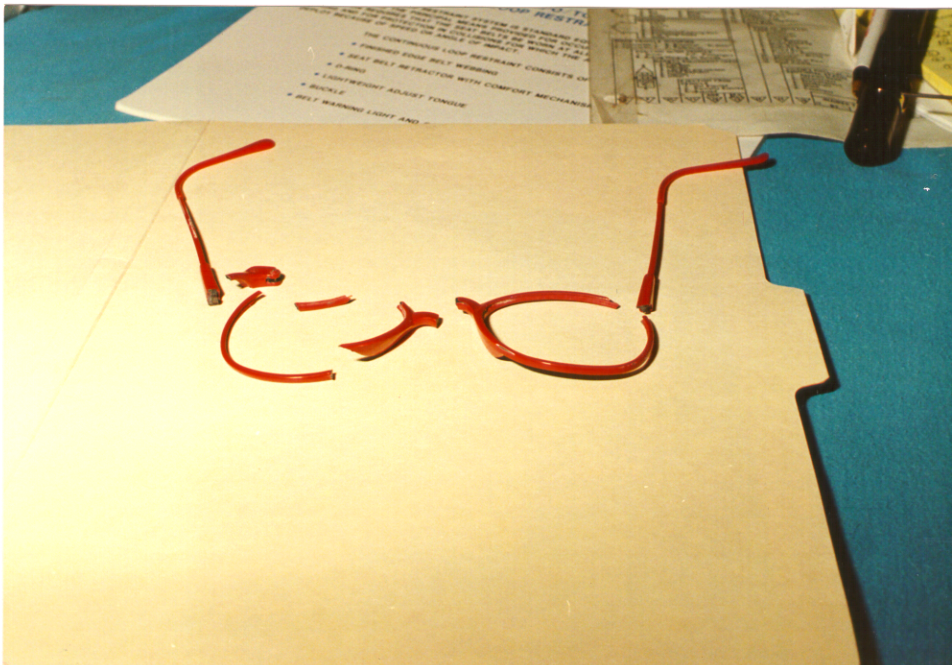
Fractured Driver's Eyeglass Frames, Graphite Material

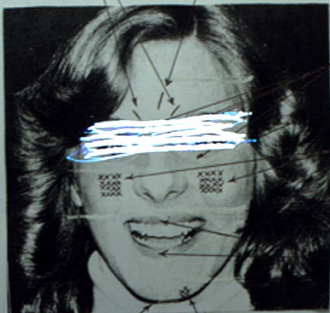
Forehead lacerations were surrounded by abrasion (AIS-1), air bag contact

2 semilunar .5" lacerations at the medial end of the eyebrows

2 cm vertical laceration of the mid forehead area (AIS-1), eyeglass frames/air bag contact

Hematoma and contusion of both upper and lower eyelids (AIS-1), eyeglass lenses/air bag contact

Abrasions of both cheeks with surrounding hematoma (AIS-1), air bag contact

Swelling of the upper and lower lips

Neck pain, arthritic condition

1 cm abrasion of the chin (AIS-1), air bag contact

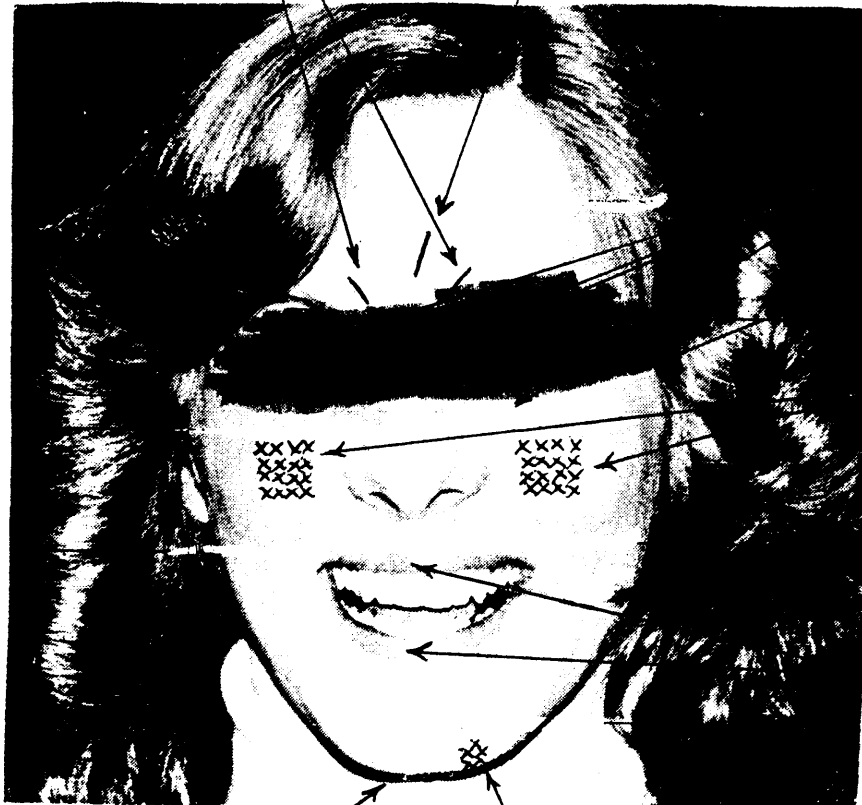
Air Bag Driver Injury Mannequin

Forehead lacerations were surrounded by abrasion (AIS-1), air bag contact

2 semilunar .5" lacerations at the medial end of the eyebrows

2 cm vertical laceration of the mid forehead area (AIS-1), eyeglass frames/air bag contact

Hematoma and contusion of both upper and lower eyelids (AIS-1), eyeglass lenses/air bag contact

Abrasions of both cheeks with surrounding hematoma (AIS-1), air bag contact

Swelling of the upper and lower lips

Neck pain, arthritic condition

1 cm abrasion of the chin (AIS-1), air bag contact

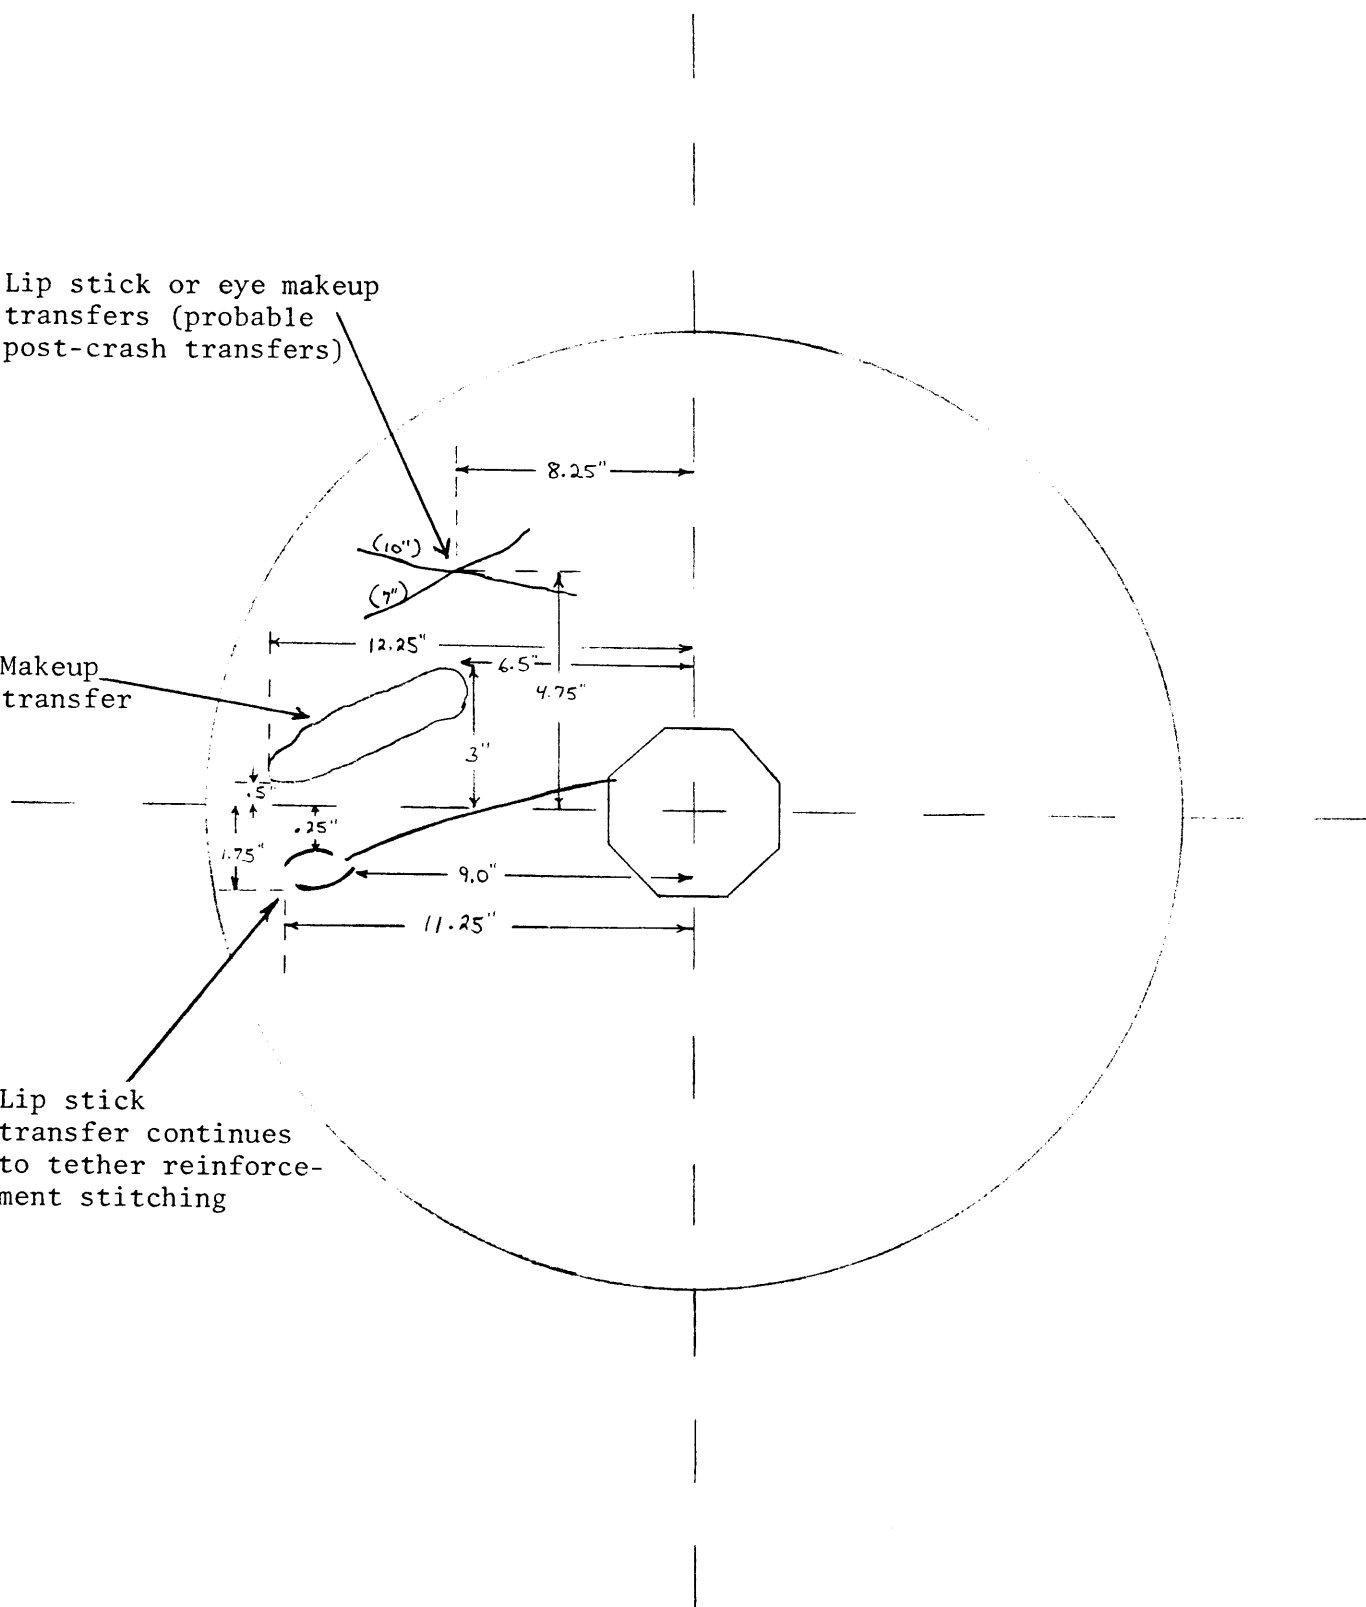
Air Bag Contact Schematic

Lip stick or eye makeup
transfers (probable
post-crash transfers)

Makeup
transfer

Lip stick
transfer continues
to tether reinforce-
ment stitching
